Top Architect Stephen Jeffrey Review's Clear Waterproofing Membrane

Balcony Inspection -

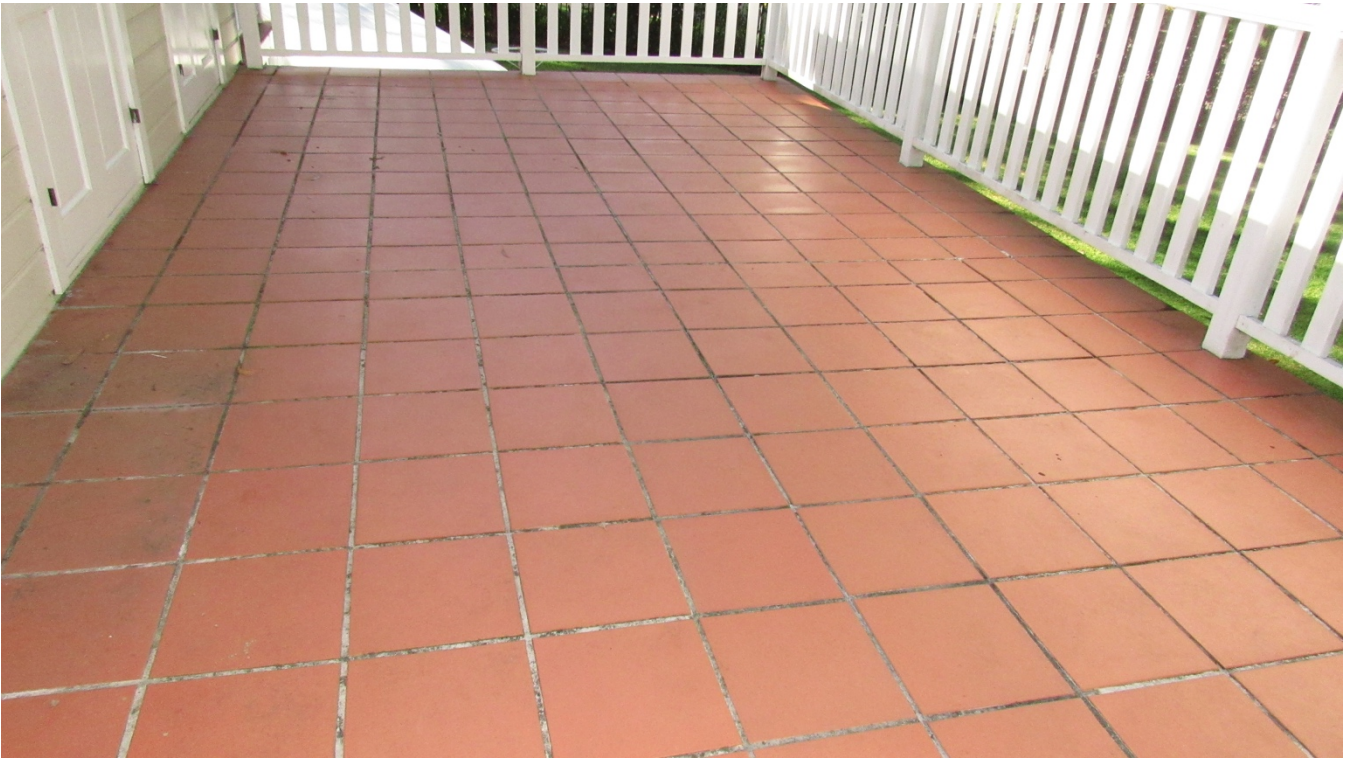
Before

Stephen advised us he had a beautiful second story wrap around terracotta balcony that had issues with water leakage. The balcony was in style with his beautiful home so it was not his first preference to rip up the tiles and lay the same ones back down after repairing the failed membrane under the tiles. He asked if Clear Waterproofing Membrane was a possible application for his balcony.

Over my time as a Director of Remedial Membranes I have had the opportunity to review numerous leaky balconies and by far the majority are Timber Framed Balconies. Unlike concrete which will move a little and then settle, timber-framed balconies move constantly and never settle. In my opinion, as movement is ongoing and expected, it is always going to fail all waterproofing membranes so it is senseless on the part of National Construction Codes & Australian Standards to install waterproofing membrane which is the most fragile material used in construction of the balcony as it will ultimately have the same untoward outcome. In the event of leaks all the tiles need to be removed to repair the damaged membrane underneath. By applying the membrane on the surface, any issue will be easily identified and patch repaired which is neither a massive cost financially or emotionally.

2. The other issue identified was the use of terracotta tiles which are made from clay; this also applies to all stones tiles. These tiles contract when it is cold and expand when it's hot which becomes further exaggerated with water. Imagine wet terracotta tiles in the heat of summer opposed to a dry cold night, the difference in the size of the tile can be dramatic so this also creates movement although not as much as with the timber-frame and this makes it harder to locate and identify the cracks.

"We have a large tiled deck that was leaking into the carport below as the membrane below the tiles had failed. Remedial membranes were able to waterproof the deck without removing the tiles. This was a great benefit for us as the tiles are no longer available and to re-tile would have meant either unnecessary retiling of other areas that were undercover or having 2 different finishes. Sean did a fantastic job of cleaning and preparing the old tiles and grout and was very thorough applying the new membrane. We are pleased to say that even after the torrential rain we have received this winter the deck is not leaking and the structure below is dry."

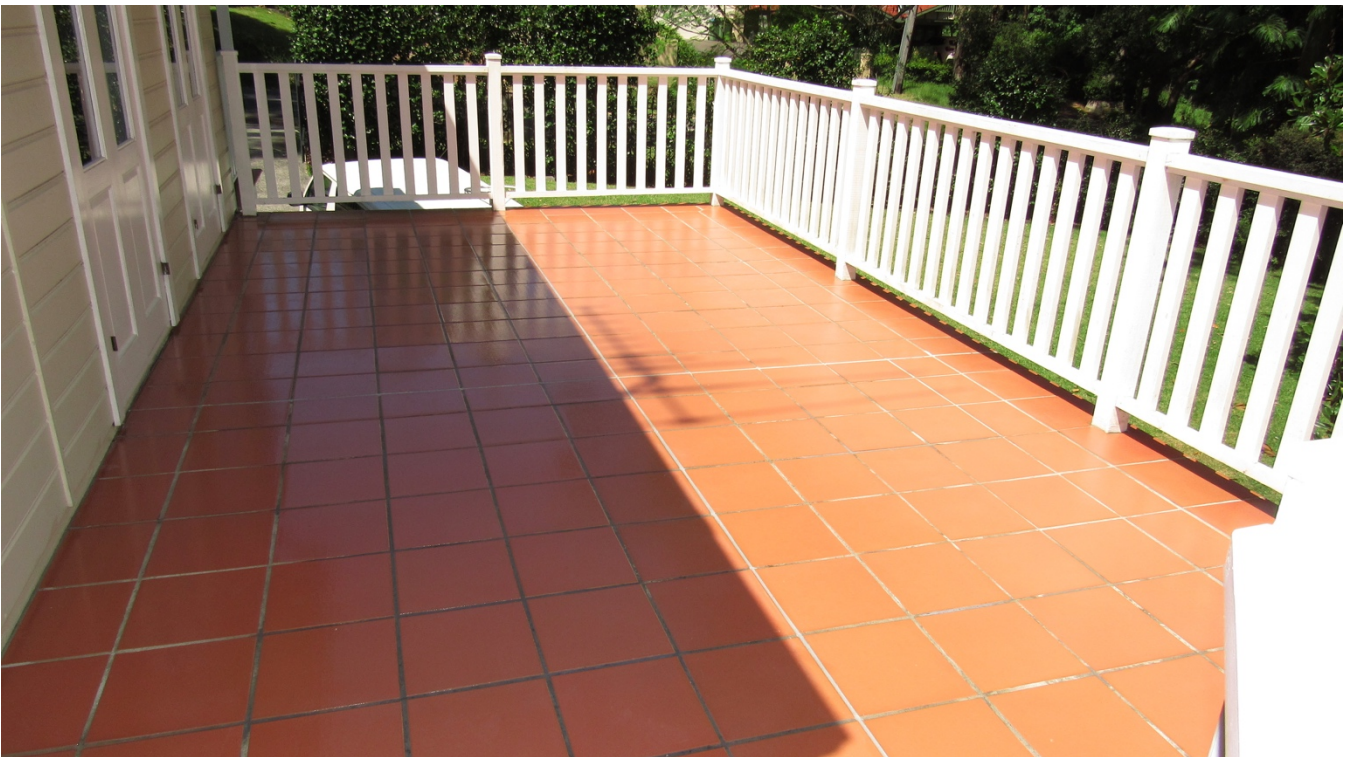
After (please note the colouration different is due to a shadow)
